## CAPUS PROJECT - CONDITION REPORT

| <b>Title of the work</b> | MANDALA (ID: OBJECT 6) | | |
| <b>Type of work</b> | MURAL | | |

| 31/03/2020 | ANTARES- CESMAR7 |

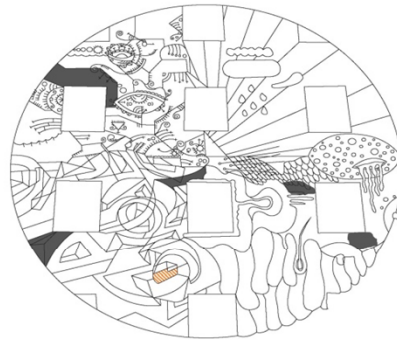
- 1 COLLAPSE
- 2 LOSS OF COHESION
- 3 CRUMBLING
- 4 INCISION
- 5 FRACTURE
- 6 **CRACKING**
- 7 OPEN JOINT
- 8 DELAMINATION
- 9 **FLAKING (moderate flaking)**
- 10 SCALING

NOTES: due to the plaster (thick and scatched plastic plaster) only moderate loss of cohesion in a limited area are present

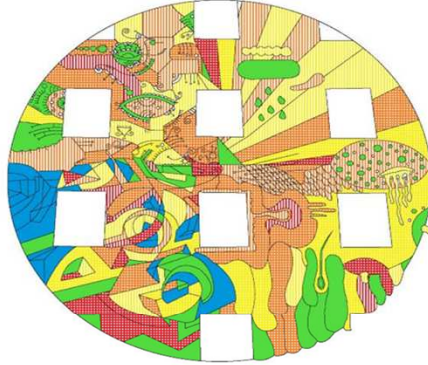
- 27 **CHROMATIC ALTERATION**
- 28 DARKENING
- 29 **FADING**
- 30 YELLOWING
- 31 WHITE VEIL
- 32 STAINING
