CAPuS PROJECT – Causes of Damage, agents and deterioration processes (WALL PAINTING)

UVIGO TEAM

APRIL 2019

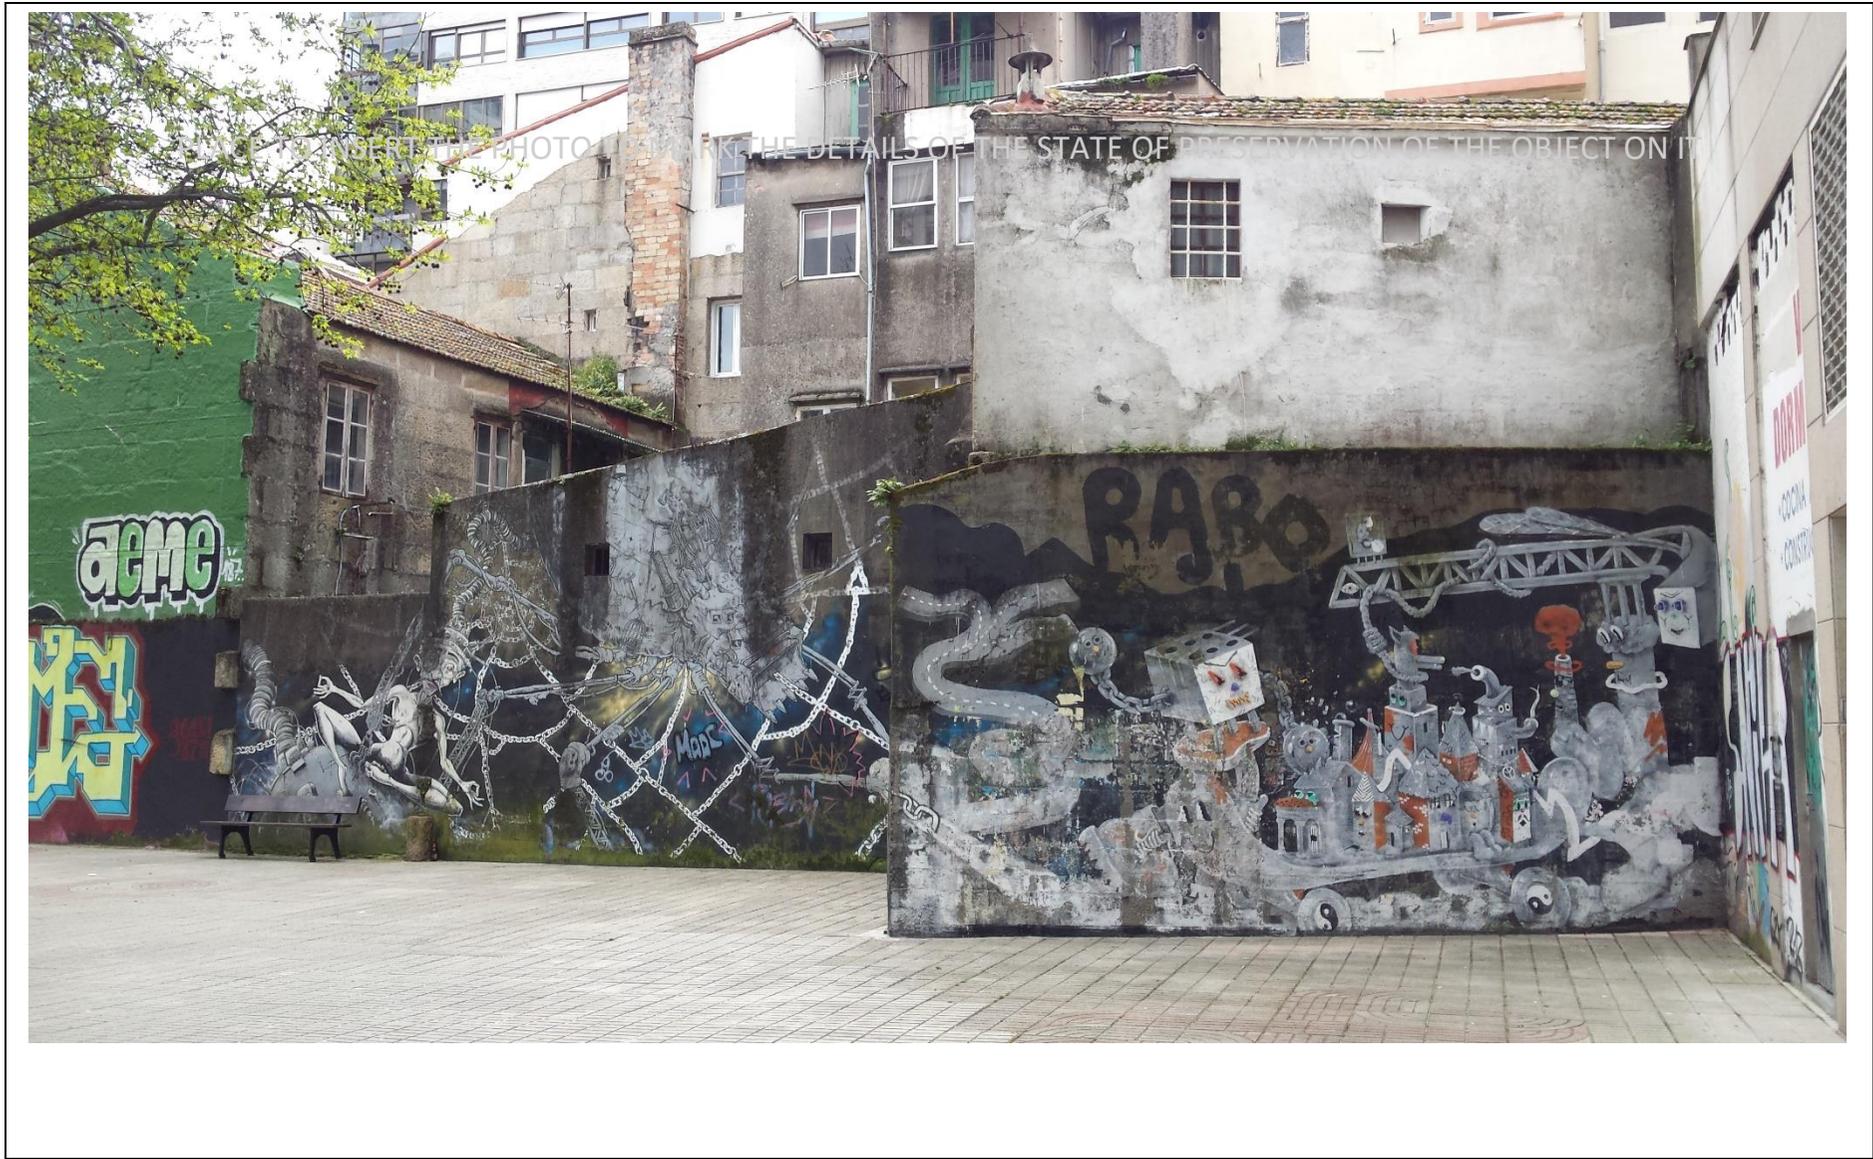
SALT IN THE AIR	
	SALT DISSOLUTION AND CRYSTALIZATION	
	CORROSION	
<u>BIOLOGICAL FACTORS (biological colonisation, biofilm)</u>		
	ANIMAL ACTIVITIES	
	MICROORGANISMS	
	FUNGUS	Evidences of MICROSCOPIC FUNGI colonization, both over and under the paint layer. Analytical confirmation needed.
	MOLDS	
	ALGAE	
	MOSS (lichens)	LICHENIC colonization, both over and under the paint layer. MOSS growth under the paintng layers
	PLANTS (SHRUBS, TREES)	Vascular plants growing near the floor on concrete hollows
<u>MECHANICAL FACTORS</u>		
	MECHANICAL INJURIES	YES
	ABRASIONS	YES, of anthropic origin
	PUBLIC ACCESS, ATTENDANCE OF THE LARGE GROUPS OF HUMANS	YES
	INDUSTRIALIZATION	
<u>OTHERS</u>		
It seems that the wall was not clean before painting. Therefore, paint layer was applied on a concrete support previously colonized by microscopic fungi and lichens. This fact decreases the durability of the paint layer and its conservation.

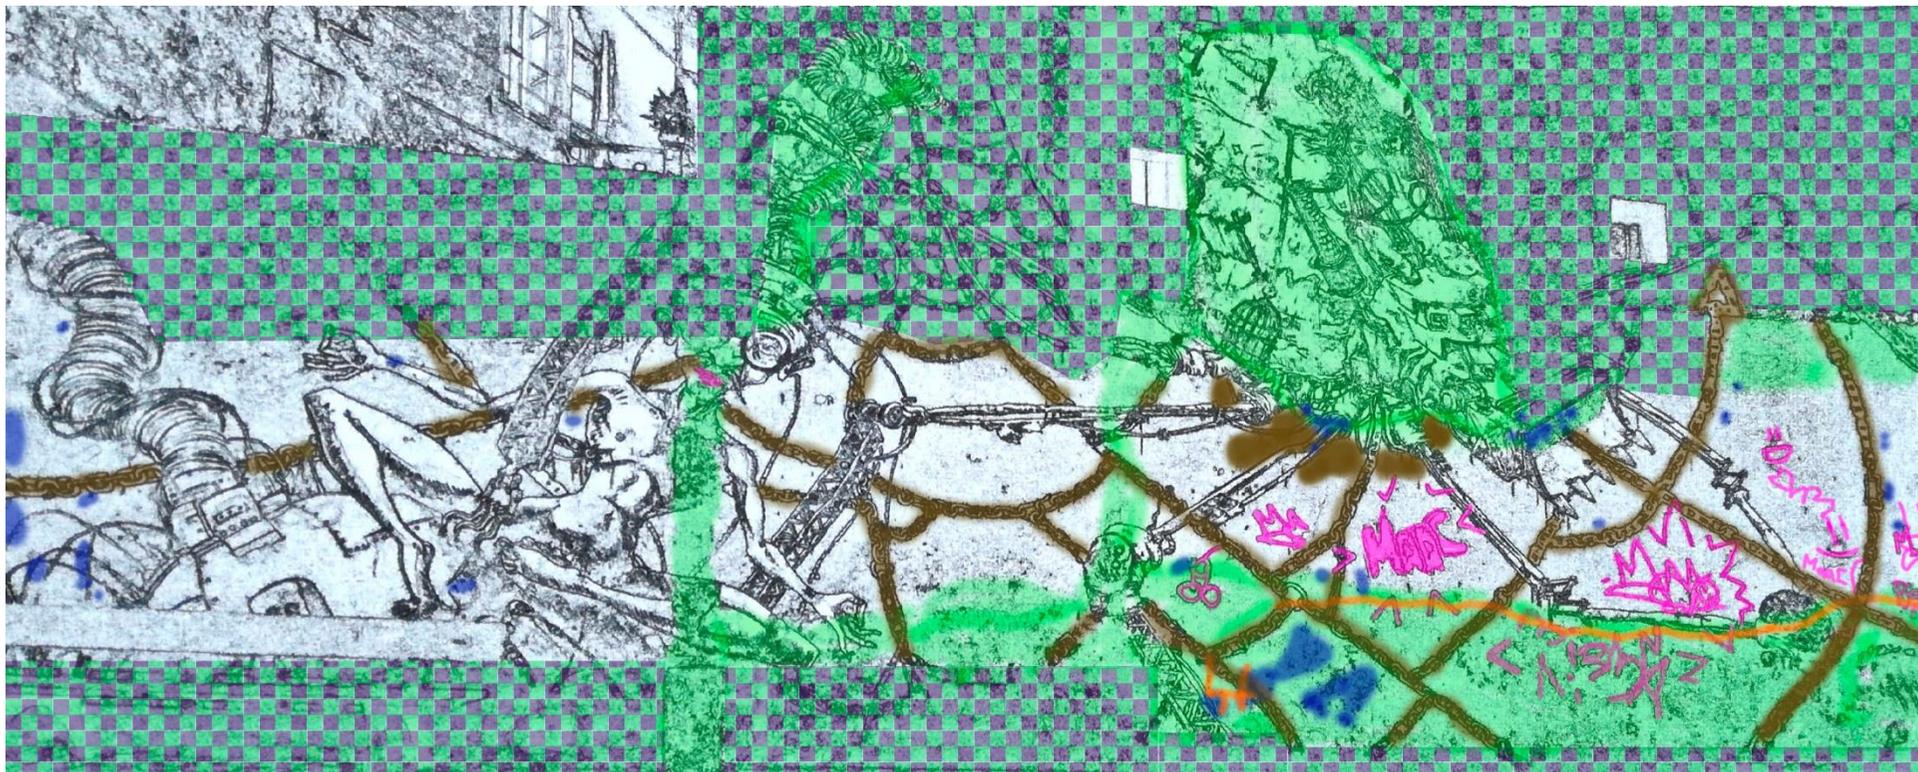
PLACE TO INSERT THE PHOTO TO MARK THE DETAILS OF THE STATE OF PRESERVATION OF THE OBJECT ON IT

BIOLOGICAL ALTERATION	Biological colonization

OPTICAL ALTERATION	Fading

LOSS OF MATERIAL-paint	Peeling

Loss

Craquelure

LOSS OF COHESION-paint and substrate	Flaking

Fissuring

ADDITION OF SUBSTANCES	Vandalic graffiti
