Object 8. *Pecado Original-SOKRAM-Ordes 2012*
 Characterization of MATERIALS-PAINTS and SUPPORT – January 2020

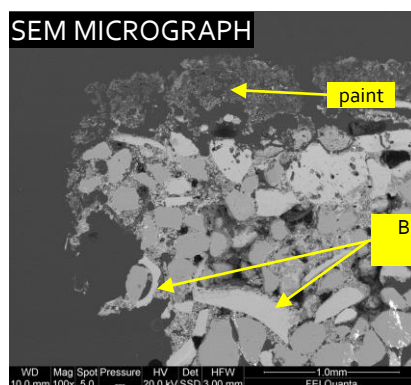
lacuna	
flacking	
Corrosion	
Biological colonization

- gypsum crystals
- Biological growth

- Corrosion of the *grey cast iron* ($FeOOH$ precipitation)

Contents up to **200 mg gypsum /100 g** in some samples of disaggregated renders and paint layers

Structural problems of the walls: many sub-vertical fractures affect the renders and the brick wall
