# Object 1. *Entaraña*-LIQEN-Vigo 2008

## Characterization of DETERIORATION FORMS – January 2020

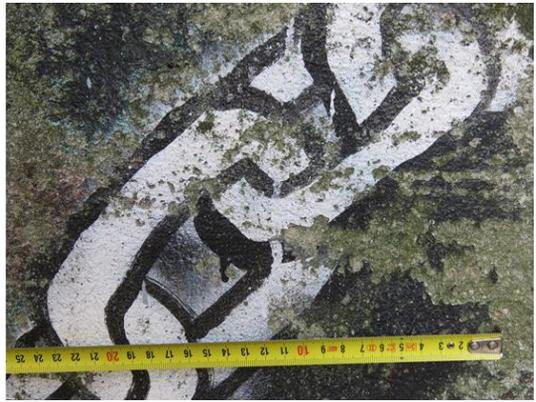
**Erosion**

Clearly related to moisture and biologic colonization

FTIR and DRX

No changes on the nature of the paints

No changes on the extenders types and content

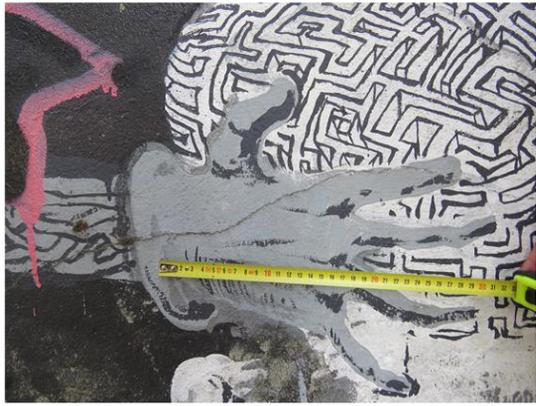
**Fissures and fractures**

Probably related to structural problems

**SEM-OPTIC MICROSCOPY**  
Physic deterioration of the paint layers related to:

- Deterioration of the concrete by water and biological growth
- **Biological growth**

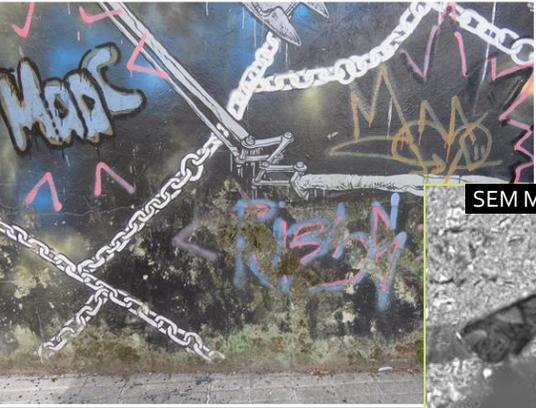
**Vandalisms**

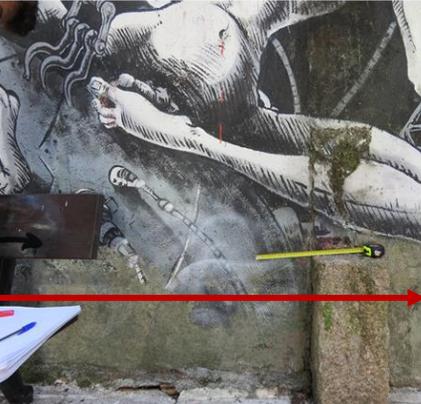
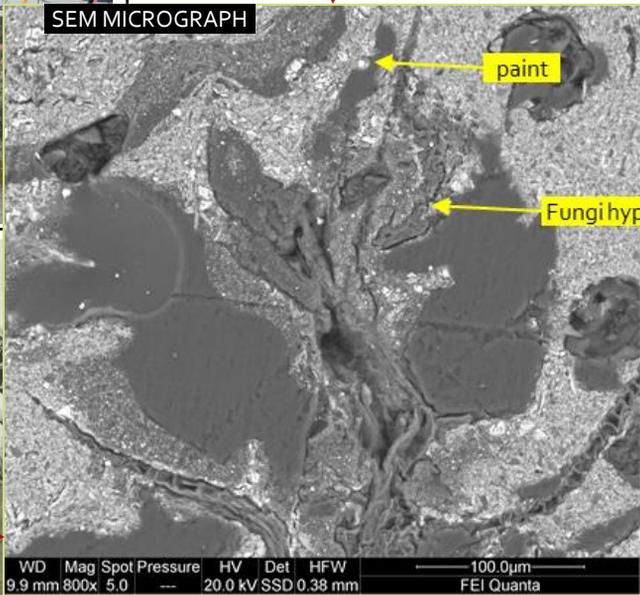
**Biological colonization**

By cyanobacteria and algae biofilms and also microscopic fungi
