Object 14. *Minero asturiano de padre gallego*-SPOK-Ordes 2015
 Characterization of MATERIALS-PAINTS and SUPPORT – January 2020

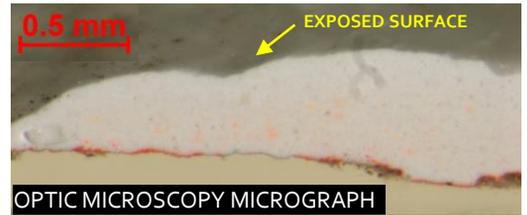
Colour modification
 (fading)

Orange fluor disappeared

In this micrograph, a cross section of the orange paint affected by fading is shown. The orange dye is only present well below the surface. In the surface, it has disappeared

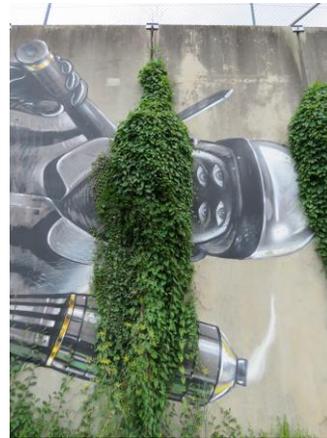
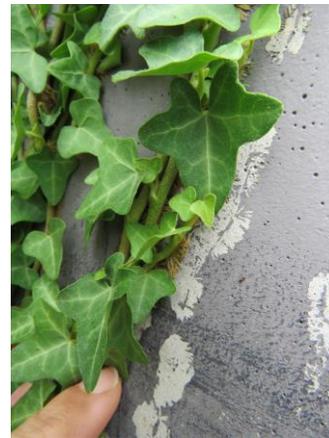
Biological colonization

Vascular plants (vines) growing between concrete slabs and upholstering large areas of the mural; when they reach a lot, they break off due to excess weight and lift the paint with their roots.

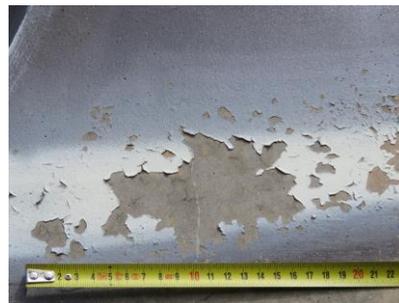
Delamination

Probably associated with expansion-compression processes due to the incidence of sunlight

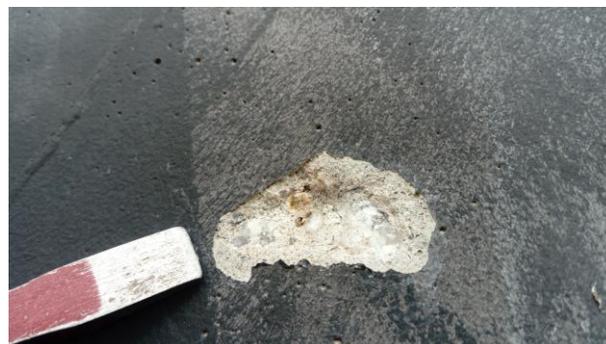
Flacking

Associated with some failures in concrete (additives?)
