# Object 26. A Guarda Escrita Nas Estrelas-Nuvi&Éxfico-A Guarda 2018

## Deterioration monitoring for 2 years (2018-2020)

The mural was painted in October 2018. The evolution of existing forms of alteration and the formation of new pathologies over 2 years ago was assessed during two visits (December 2019 and January 2021).

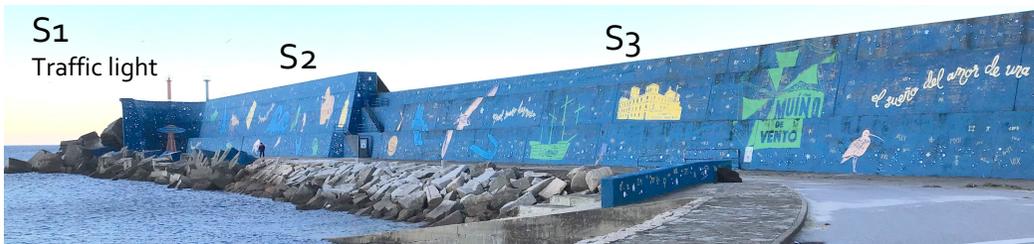
**STRUCTURE OF THE BREAKWATER :** 4 modules, one semicircular (S1, with a traffic light), all made of reinforced concrete of variable roughness. After a big storm (2017), the second module (S2) was partially reconstructed with a smoother concrete.

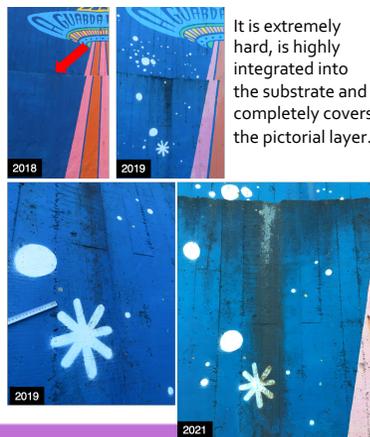
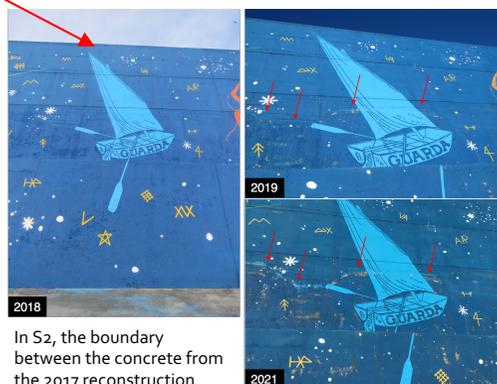
**Black patina**, sometimes greenish-brown, it is distributed following runoff lines that start from the steps, where water and organic matter (macroalgae) accumulate.

It is extremely hard, is highly integrated into the substrate and completely covers the pictorial layer.

In S2, the boundary between the concrete from the 2017 reconstruction and the old concrete (red arrows) is affected by CaCO<sub>3</sub> concretions (suggesting water infiltration). In the newer, smoother concrete, the paint is better preserved than in the old, rougher concrete, where the **delamination** is much more intense.

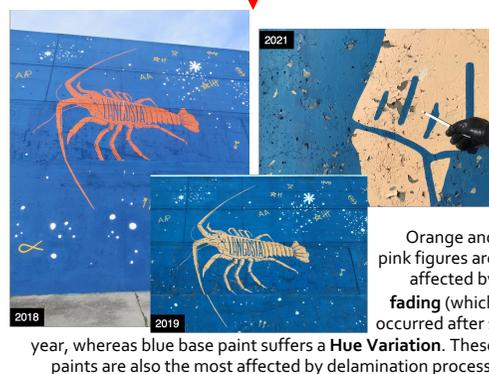
Orange and pink figures are affected by **fading** (which occurred after 1 year, whereas blue base paint suffers a **Hue Variation**). These paints are also the most affected by delamination process.

**Delamination** (loss of the pictorial layer that comes off the substrate) is, together with **black patina** and **colour changes**, the main form of alteration of the mural. It especially affects blue base paint, spray orange and spray blue paints. The areas painted yellow and green are not affected by this alteration and are much more resistant.

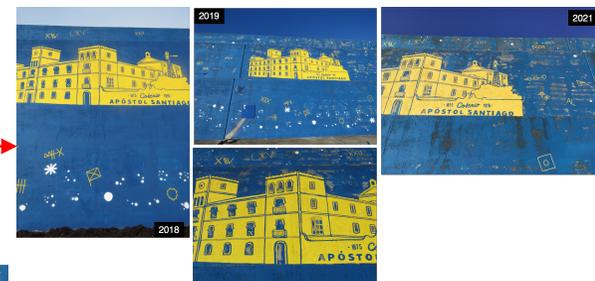
The **color deterioration** of the base blue paint is very clear in these images: a color protector was applied in the area of the square in 2018. In 2021, the unprotected blue paint lost its color whereas the protected area remained unaltered. Note the intense **delamination** affecting blue base paint.
