<b>NUMBER OF PARTNER:</b>	P3 Cesmar7, P4 An.t.a.res srl Unipersonale
<b>TYPE OF WORK:</b>	Mural painting
<b>COUNTRY:</b>	Italy
<b>CITY:</b>	Milan
<b>ADDRESS:</b>	Via Ettore Majorana/Via Graziano Imperatore
<b>OWNER / CUSTODIAN:</b>	Municipality of Milan
<b>ARTIST:</b>	VolksWriterz
<b>TITLE OF THE WORK:</b>	Niguarda Antifascista
<b>YEAR OF EXECUTION:</b>	2014
<b>MATERIALS:</b>	housepaint and spray

This document was produced within the project *Conservation of Art in Public Spaces (CAPuS)*.

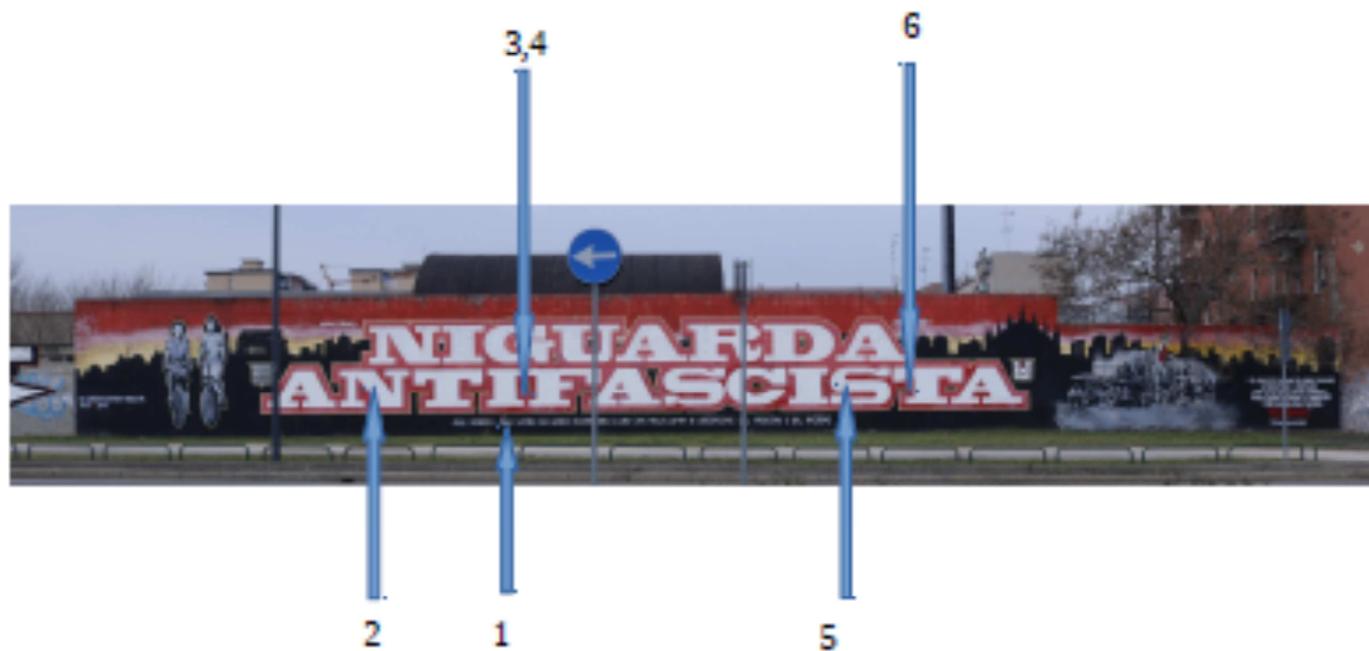
Fig. 1 "Niguarda Antifascista" – sampling location

Sample 1 was collected from a black area painted by brush (**fig.1-2**) completely detached (scaling).

Sample 2 was collected from a white area painted by brush (**fig.1**) completely detached (scaling).

Sample 3 was collected from a deteriorated red area painted by brush (**fig.1**); it is not original.

Sample 4 was collected from a biodeteriorated red area painted by brush (**fig.1**); it is not original.

Sample 5 was collected from a white area painted by brush (**fig.1**) completely detached (scaling).

Sample 6 was collected from a red area painted by brush (**fig.1**) detached and a bit faded.

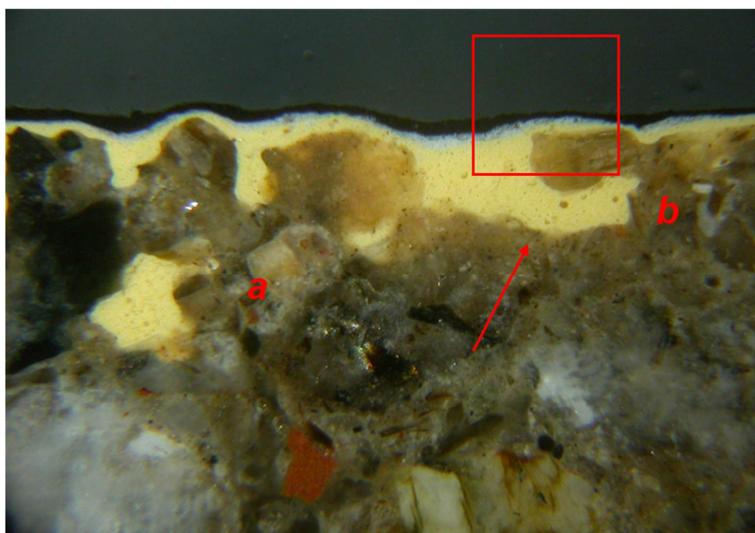
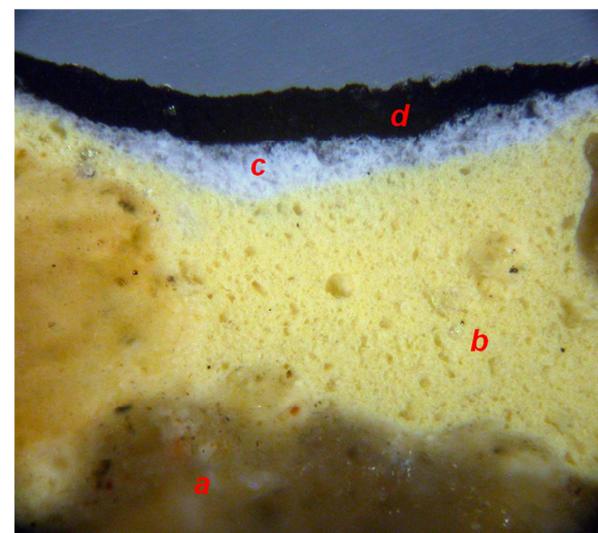
**Fig. 2** “Niguarda Antifascista” – sample 1 – cross section – reflected Visible light – magnification 35 x (left) 150 x (right)

The study of the sample has shown the following structure and composition:

- a)** Concrete based plaster support, thickness > 1 cm, at low quality (full of glass and rust fragments) containing crystalline silica mineral Quartz;
- b)** Yellow ground layer at irregular thickness, 300 µm max thick, containing Calcite, Rutile and probably PY74 acetoacetic arylide;
- c)** White paint layer (prime coating) with the same composition of layer *b*, irregular feature, average thickness of 50 µm;
- d)** Black paint layer at regular feature, average thickness of 70 µm, the black pigment has not yet been identified.

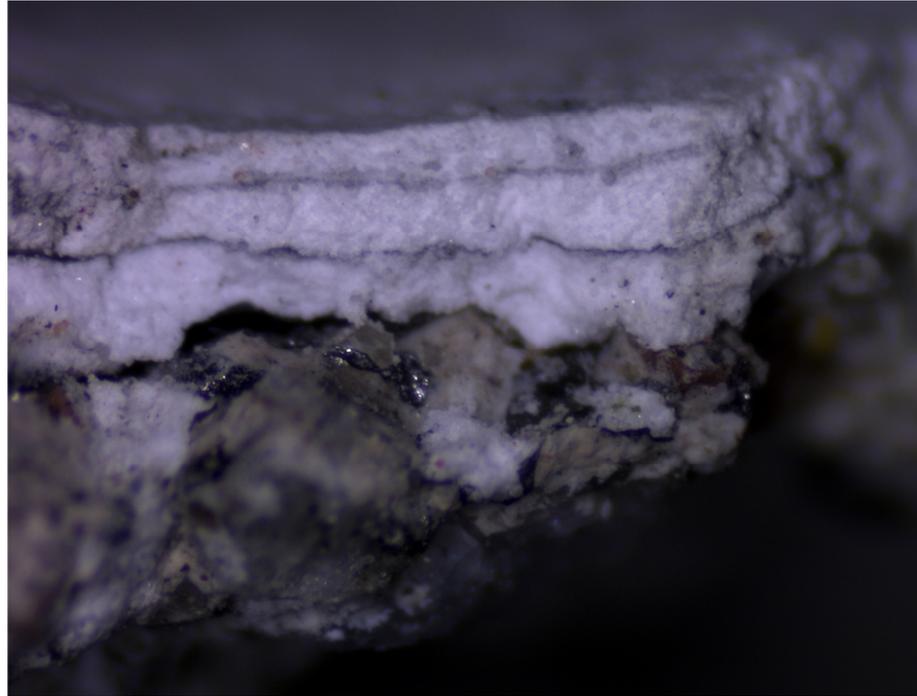
**Fig. 3** "Niguarda Antifascista" – sample 2 – reflected Visible light – magnification 45 x

The study of the sample has shown the following structure (**fig.3**):

- a)** Concrete based plaster support, thickness > 1 cm, at low quality (full of glass, rust fragments, insect nest);
- b)** White paint layer, irregular thickness, 230 µm thick;
- c)** (Thin red paint layer, discontinuous, only sometimes);
- d)** White continuous paint layer, average thickness of 180 µm;
- e)** White paint layer, average thickness of 140 µm, it seems a not original paint color.

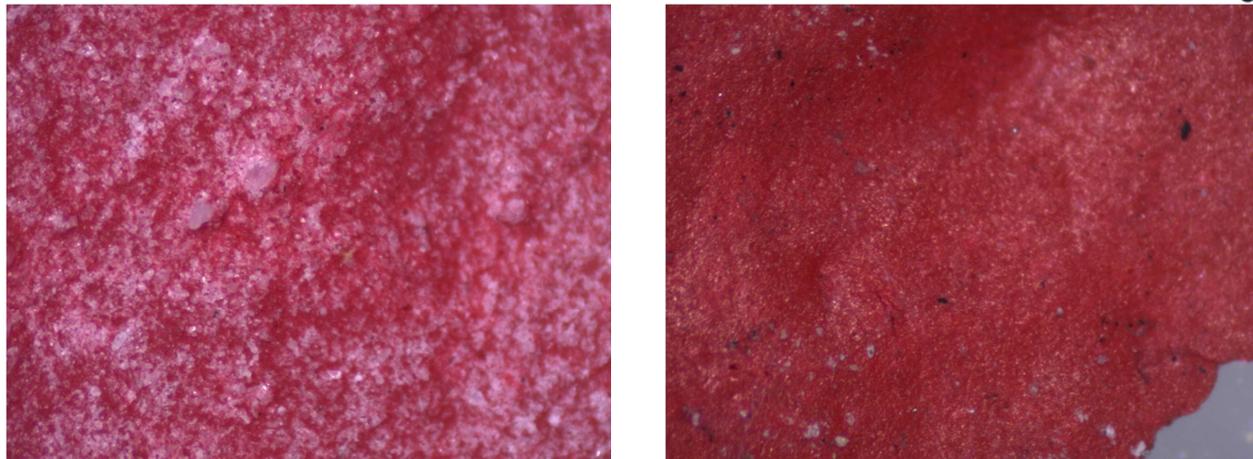
**Fig. 4** “Niguarda Antifascista” – sample 3 - reflected Visible light – recto (left) e verso (right)- magnification 45 x

The sample has shown the presence of a poly vinyl acetate resin, Calcite and the following structure (**fig.4**):

- a)** Red and glossy chip, about 100 µm thick;
- b)** Thin whitish patina, irregular feature

This sample has been addressed to Py-GC-MS.

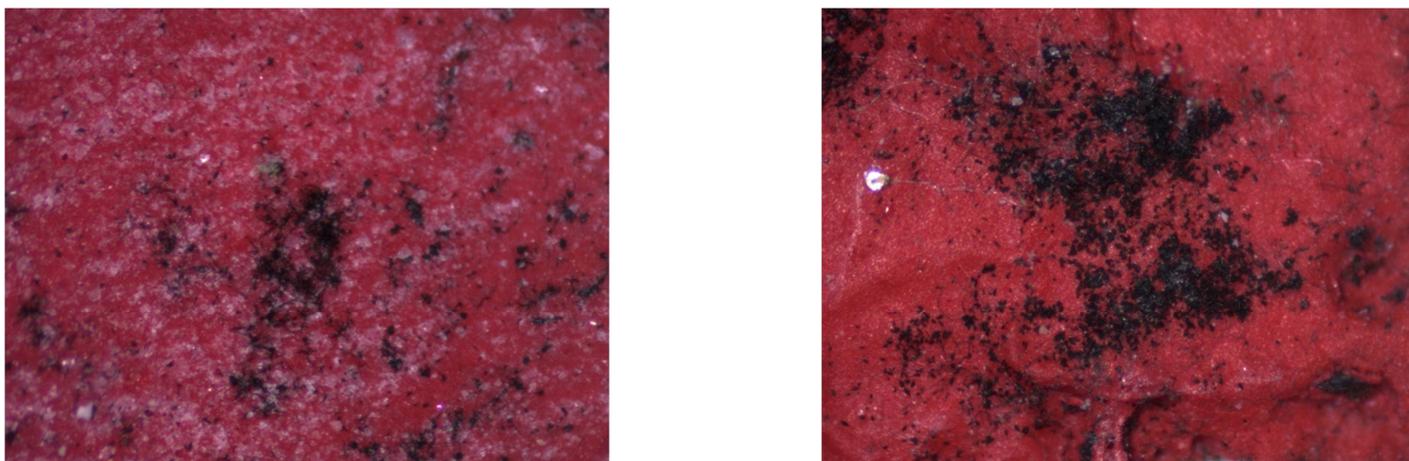
**Fig. 5** “Niguarda Antifascista” – sample 4 - reflected Visible light – recto (left) e verso (right)- magnification 45 x

The sample is similar to sample 3 with dark bio patina (**fig.5**).

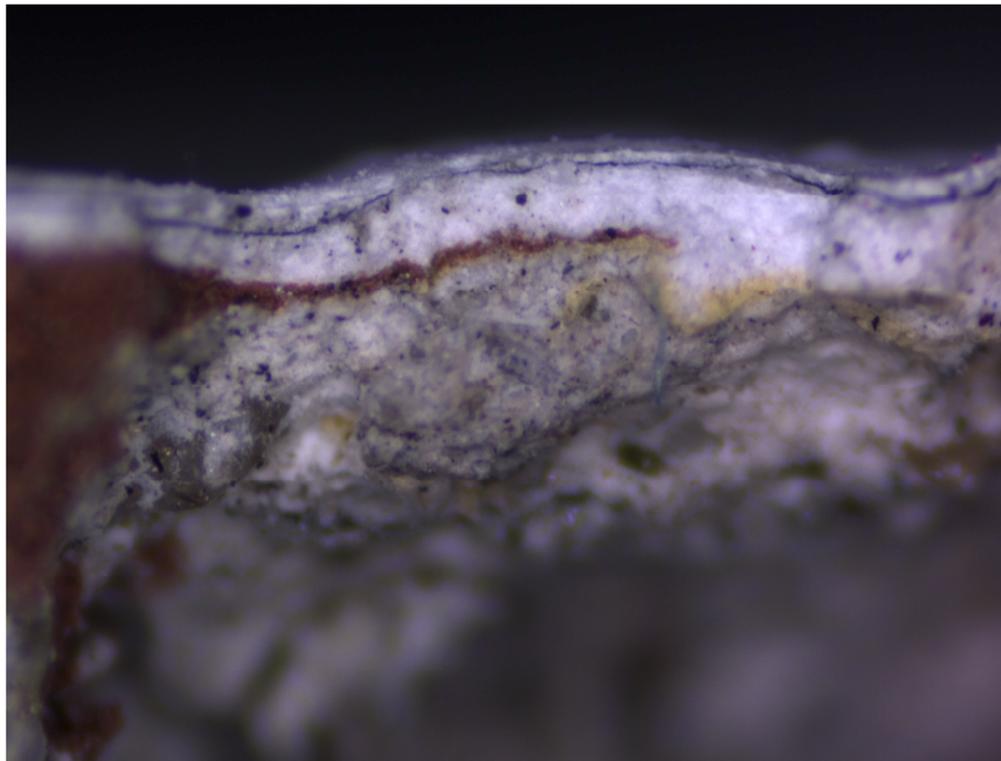
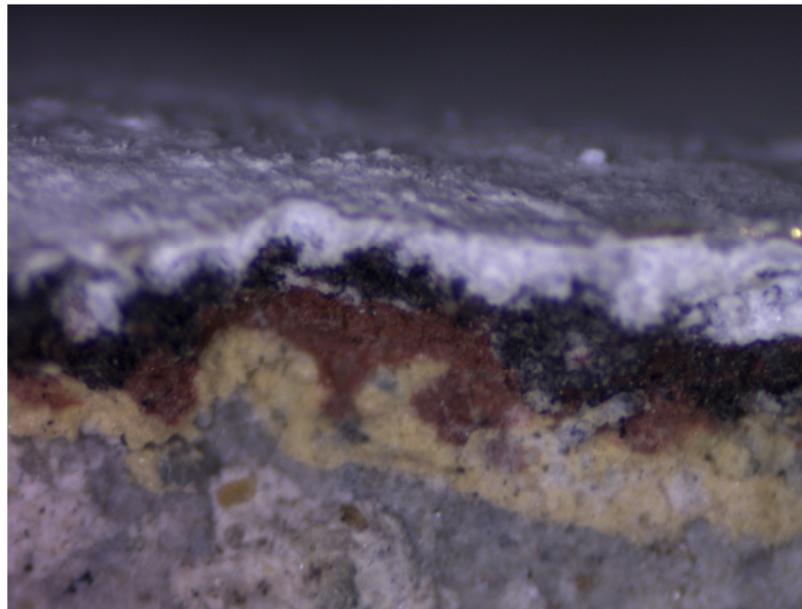
**Fig. 6** “ Niguarda Antifascista ” – sample 5 - reflected Visible light - magnification 45 x

The study of the sample has shown the following structure (**fig.6-7**):

- a)** Concrete based plaster support, thickness > 1 cm, at low quality;
- b)** Yellow ground layer at irregular thickness, 315 µm max thick;
- c)** White paint layer (prime coating);
- d)** Thin white paint layer, irregular thickness, 30-45 µm thick;
- e)** Thin white paint layer, irregular thickness, 30-45 µm thick, realized after the *d*) layer.

Additional layers have been observed in a portion of the sample without the *c*) primer, likely due to a vandalism:

- b1)** Red ground layer, irregular feature, 120-187 µm thick;
- b2)** Thick black paint layer (130-150 µm up to 193 µm), irregular feature, due a graffito (swastika).

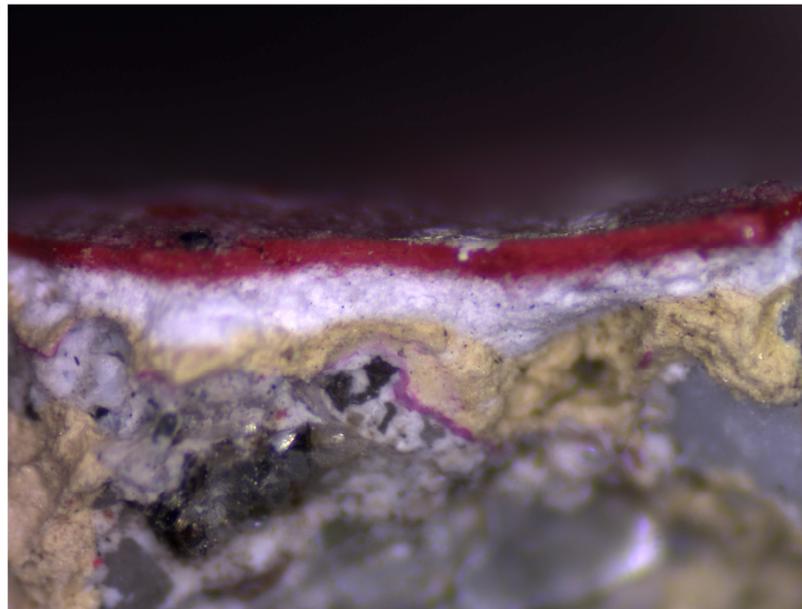
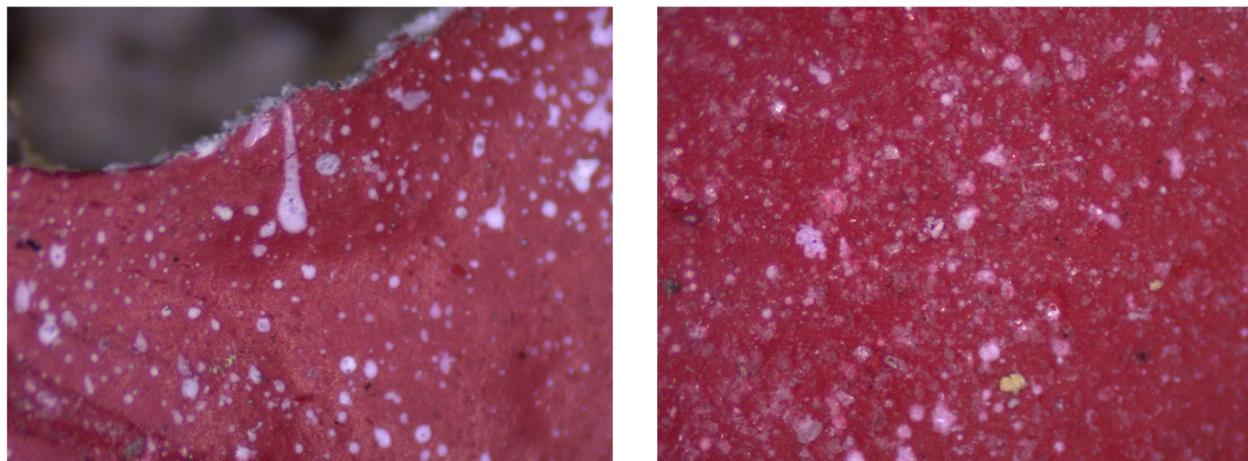
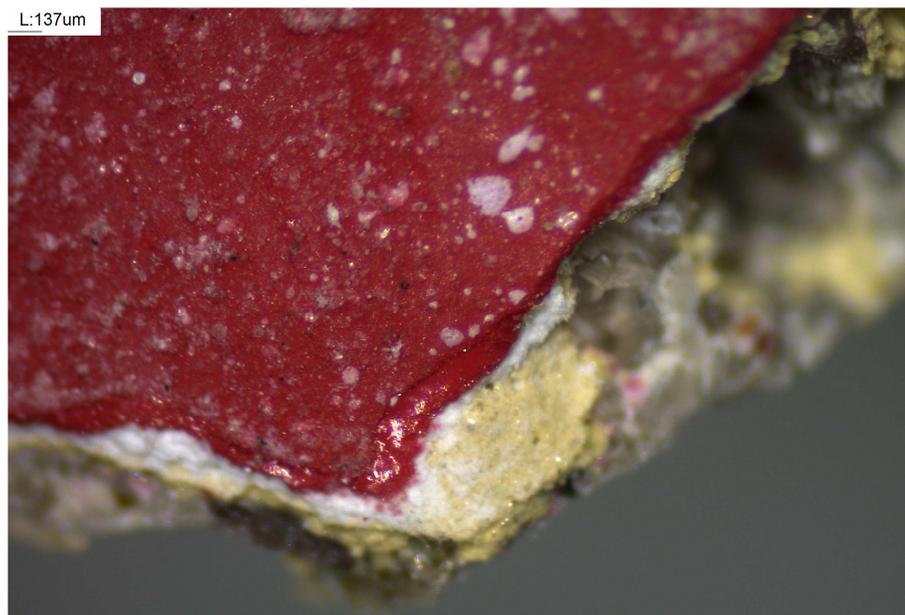
**Fig. 8** " Niguarda Antifascista " – sample 6 - reflected Visible light - magnification 45 x

The study of the sample has shown the following structure (**fig 8-10**):

- a)** Concrete based plaster support;
- b)** Very thin (4-7  $\mu\text{m}$ ) magenta paint layer, irregular, it is probably the original outline of the letter before painting;
- c)** Yellow ground layer, continuous, irregular thickness, from 150 to 400  $\mu\text{m}$  thick;
- d)** White paint layer (prime coating), up to 300  $\mu\text{m}$  thick;
- e)** Red paint layer, about 70  $\mu\text{m}$  thick, continuous, containing alkyd resin with Calcite, likely silicates and pigment as Naphtol AS (PR22) or family (es. PR8, PR18). Whitish patina has been observed on the top the micro-sample. This paint layer has been addressed to Py-GC-MS.
